## Finding Faults in Residential Buildings

### ABSTRACT

Buildsure is a private company which has provided house inspection services since 2004. Some 700 inspections have been completed, the majority for a pre-sale house condition assessment. This results in a detailed report and a “House Warrant of Fitness”.

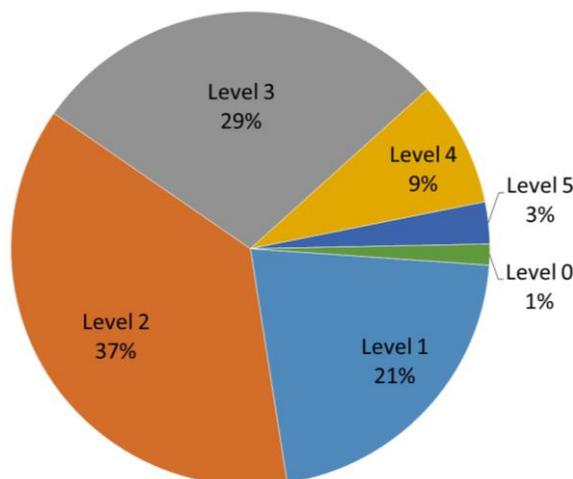
**Figure 3: Estimated Maintenance Level**

For each of the houses an estimate level of maintenance was allocated. This was based on the general descriptions as well as the specific detailed recorded for each component. Table 1 provides a brief description of the levels, from level 1 where the house has excellent maintenance through to level 5 where the houses of more than two major problems e.g. moisture problems and asbestos very likely to be present. Figure 3 plots the data, showing that the large majority (87%) of the inspected houses had between level 1 and level 2. Only 12% of the houses had major maintenance problems to be dealt with.

Maintenance Level	Percent
1. Excellent	21%
2. Minor, General Wear & Tear	37%
3. Wear & Tear plus 1 noticeable issue	29%
4. Poor condition plus 1 or 2 major problems	9%
5. Major problems (more than 2)	3%
0. Missing/Insufficient data	1%
<b>TOTAL</b>	<b>100%</b>

While in one way this is a reassuring result, suggesting the majority of householders maintain their homes in reasonable condition, on the other hand only one fifth (21%) had houses in an excellent state of maintenance suggesting there is considerable room for improvement.

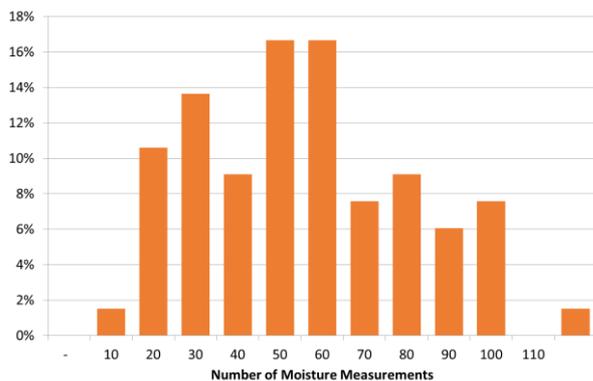
**Figure 4: Distribution of number of moisture measurements made in each house**

Detailed moisture measurement data was available for 66 houses in the sample. In each house a number of measurements were made of the moisture levels – a minimum of 8 and a maximum of 112 measurements. Figure 4 shows that in 52% of the houses more than 50 readings were made.

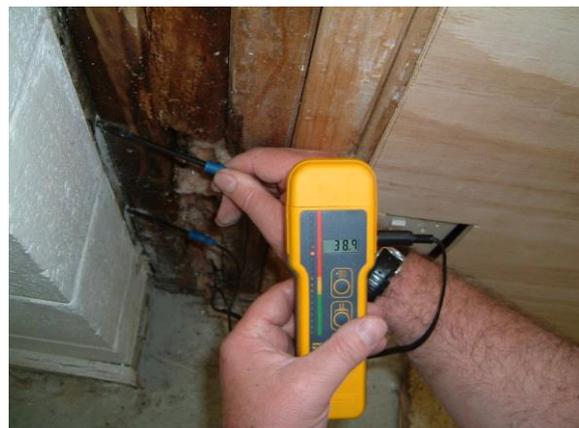
**Figure 5: Surveymaster Protimeter in use on a piece of rotten timber**

Moisture readings are measured using an electronic Surveymaster Protimeter<sup>5</sup> which provides both a digital read out and a scale of colour-coded lights. Figure 5 provides an illustration of the Protimeter in use. Moisture readings are taken on the inside wall of all external openings, heads, jambs and sills. Where any areas visually indicate moisture ingress, then readings are also taken at those points.

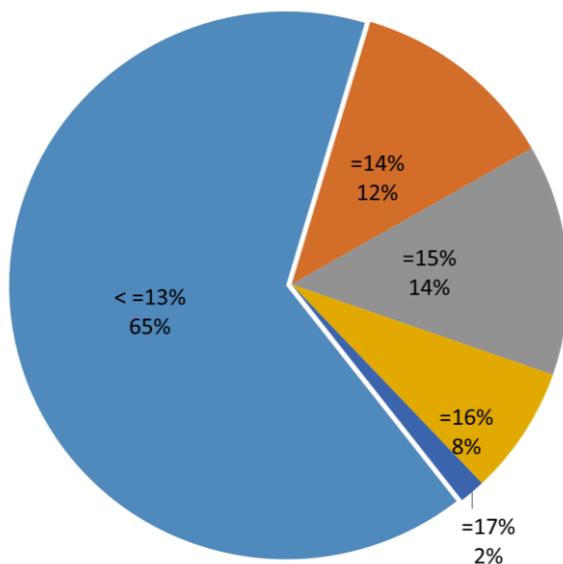
**Figure 6: Proportion of Houses With given Mean Interior Wall Moisture Level**

Figure 6 shows the proportion of houses by count by the mean moisture level. Nearly two thirds (65%) of the inspected houses had mean moisture levels below 13%. A moisture reading of 14% is considered the point at which “borderline” risk presents itself.

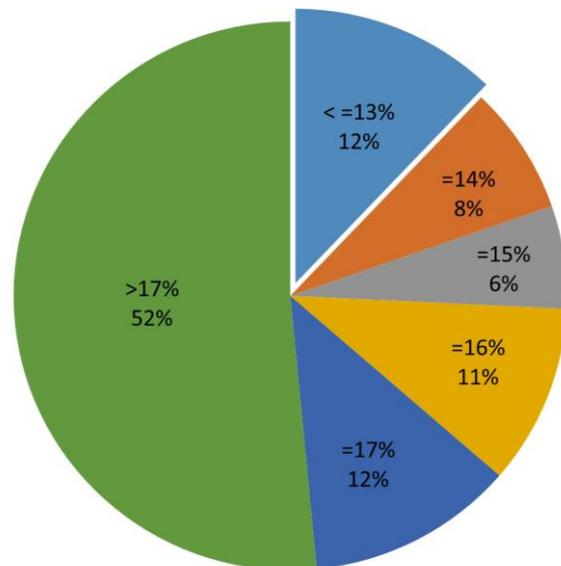
**Figure 7: Proportion of Houses with given Maximum Interior Wall Moisture Level**

However, the use of the mean moisture level as a measure disguises the distribution of moisture levels – the average of 13% and 13% is the same as the average of 9% and 17%, yet in the first case there should be no moisture problem but in the second case the situation is very different. Figure 7 shows the proportion of houses by count by the maximum measured moisture level. Just 12% of the inspected houses had a maximum moisture level of below 13%. In 88% of the houses the moisture level was so high in one or more locations as to give concern.

Figure 7 shows this is the situation in 23% of the inspected houses.

In softwoods, the main timbers used in New Zealand houses, once the moisture content is above about 14% any further increase in the moisture content would be likely to produce: degrading of the timber strength; corrosion of fixings; expansion of the timber in the fixing cavities; mould growth; and finally degradation of finishes (paint/wallpaper etc.). At around 16% moisture content, fungal attack is likely to occur, with the possibility of danger to occupant’s health [Andrews 2002, Lstiburek 2002]. These expectations are matched by the experience of house surveyors.

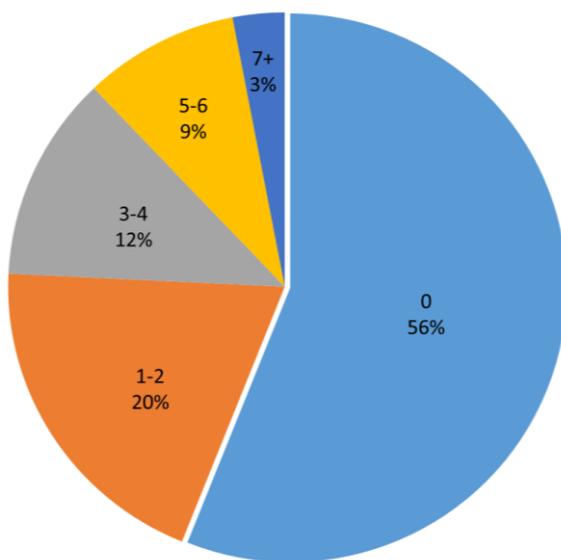
**Figure 8: Proportion of Houses with Interior Wall Moisture Levels Above 18%**

Figure 8 shows the proportion of houses with the given number of moisture readings over 18%. While just over half of the houses (56%) had no locations with a moisture level above 18%, in 3% of the houses there were 7 or more locations with moisture levels above 18%. The majority of cases where the moisture level is above 18% are a direct result of poor maintenance by the owner or the owner’s agents. There was no obvious relationship between house age and the finding of higher levels of moisture – high levels could be found in very new or very old houses. The only difference is that

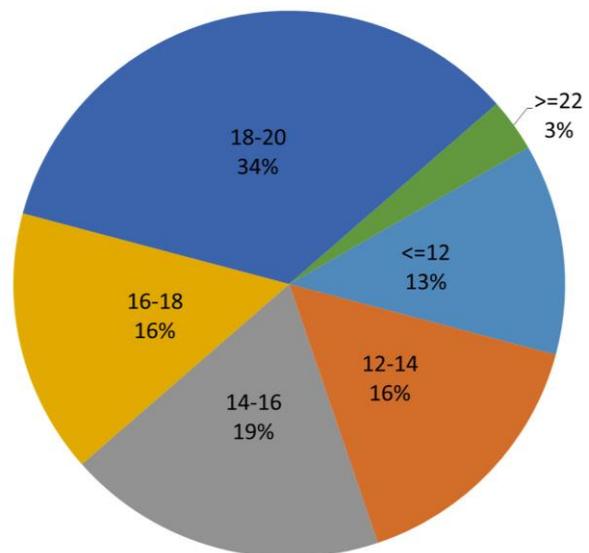
**Figure 9: Proportion of Houses with Sub-floor Moisture Levels**

Where there was a sub-floor, moisture measurements of the bearers are also made as part of the inspection. A total of thirty-two sub-floor moisture measurements were available for analysis, of which Figure 9 shows that over half (53%) were in the 16% to over 22% range. This is a high, and ultimately unacceptable, level of moisture.

New Zealand does not have a tradition of basements – houses are built directly over the ground, raised on piles or foundation walls. Ground moisture will evaporate from the earth over time, and unless removed will build up to unacceptable levels that can lead to decay of timber and corrosion of fittings. This can be a particular problem when ground water is high or external surface water can enter the sub-floor space. Methods for controlling sub-floor moisture include the use of ventilators to ensure adequate external air can ventilate and remove the moisture, or damp proof membranes (DPM) to stop the moisture entering the sub-floor space. Evidence of unacceptably high sub-floor moisture, and hence failure of either ventilation or DPM, can be detected through high levels of moisture in timber bearers or sub-floor framing.
